King County's efforts to properly maintain the South Park Bridge and keep the bascule spans operational have resulted in numerous bridge inspections and engineering studies. Since 1990, over 30 studies have been conducted that evaluated the soils, analyzed deficiencies, assessed load carrying capacities, and endeavored to determine its remaining life. The objective of this technical memorandum is to provide the County with a single document that contains a peer review of relevant studies, compares the South Park Bridge with similar bridges in the Seattle area, identifies risk factors for the existing bridge, and offers recommendations for next steps.

1.2 PEER REVIEW

The reports reviewed for this memorandum, all conclude the South Park Bridge is in need of major rehabilitation or replacement. While these conclusions are similar, the approach and methodologies which led to these conclusions varied amongst the documents reviewed, due to the complexity and uncertainties associated with the bridge structure.

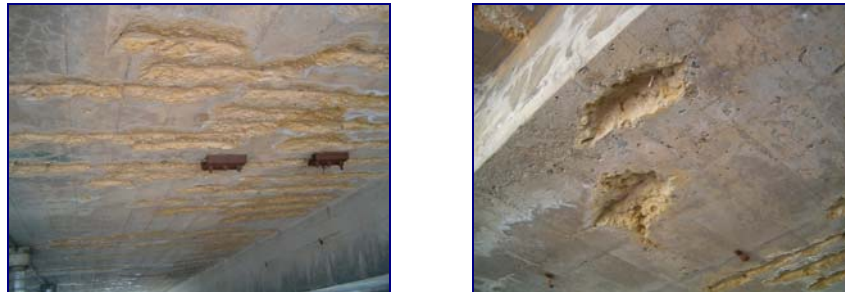
The concrete deck exhibits the cracking, spalling, and reinforcement corrosion that are typical of the substructure. Further exacerbating this condition is the fact that Boeing at one time stored chemical tanks under the bridge spans that are believed to have created an atmosphere that added to the concrete degradation.

Concrete spalling and exposed reinforcing steel on underside of deck

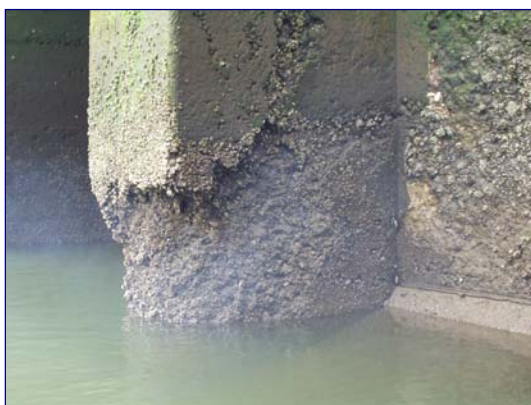
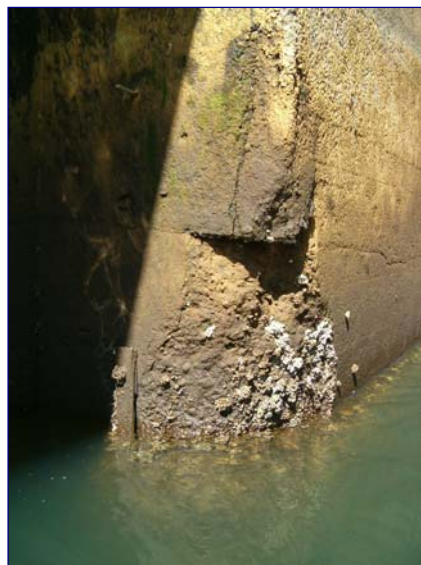
Representative concrete section loss on exterior of bascule piers

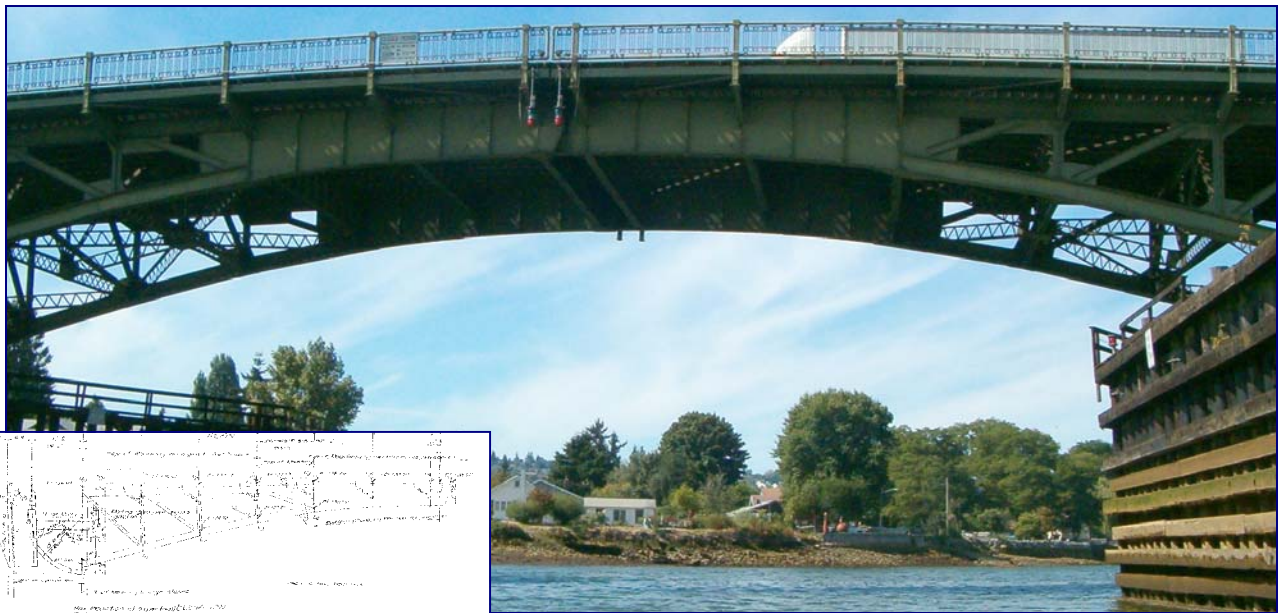
Rolling end of bascule leaf and support track

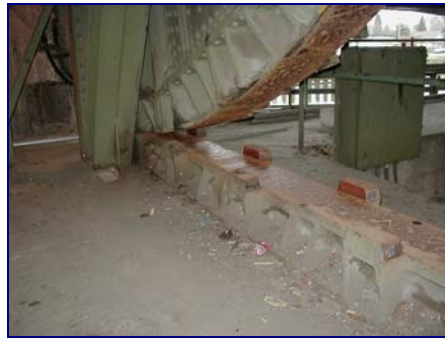
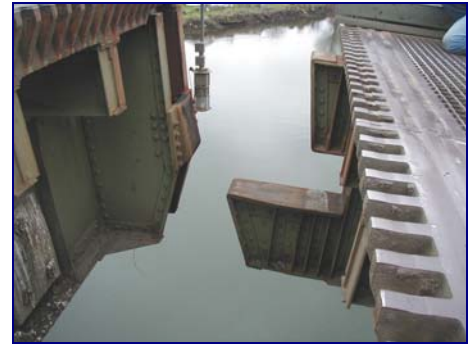
Interlocking jaw locks

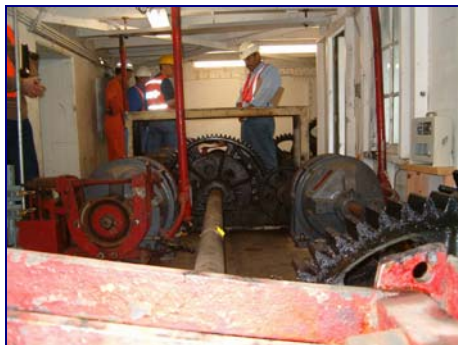
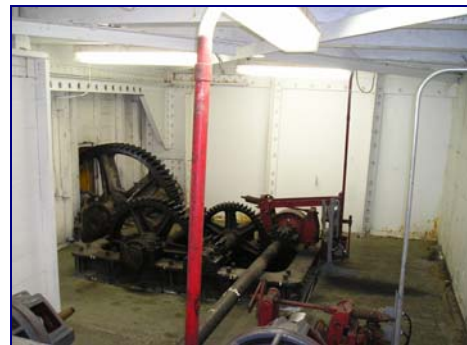
Bascule leaf room and machinery

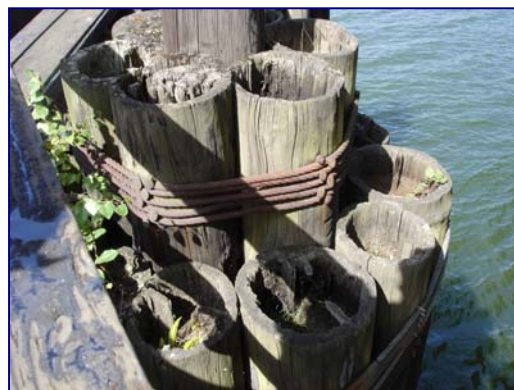
Overall condition is fair. A cursory inspection of the condition of the timber fendering system was performed. Significant biological deterioration in the form of fungal decay or dry rot was noted in the tops of the piles. The lower portions of the piles are essentially sound and capable of serving the design function.

It is recommended that the fendering system be included in all future inspections. The timber system is showing signs of deterioration, with the tops of the piles in the dolphins having been partially crushed by the cable wrappings. The timber fender system does not appear to have lost the ability to function as required.

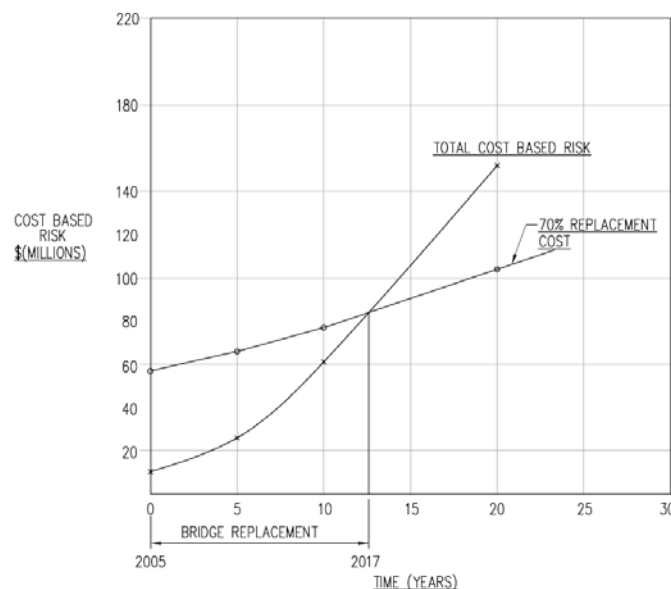
Figure 10.1 is a plot of key information provided in the Risk Analysis Summary spreadsheet. The figure provides a visual representation of the predicted remaining time to bridge closure and, therefore, replacement. The cost-based risk values are plotted overlying a plot of the variation in the threshold cost with respect to time. The intersection point of these two plots occurs within a time period of approximately 12 years beyond 2005. Based on these results, the South Park Bridge should be scheduled for replacement by the year 2016.

The results of the analysis also indicate that the event most likely to lead to closure is the 190-year return seismic event. Specific causes for closure will likely include extensive structural damage to one or both approach spans, and/or additional bascule leaf rotation sufficient to close the center break gap to prevent opening and closing of the bridge.
